Impact of Dredging the Okpoka River on Coastal Infrastructure: A Case Study of the Akpajo Bridge

Tamunoene Kingdom Simeon Abam¹, Tamunotonye Oba² and Robert Egwu Otu Iduma³

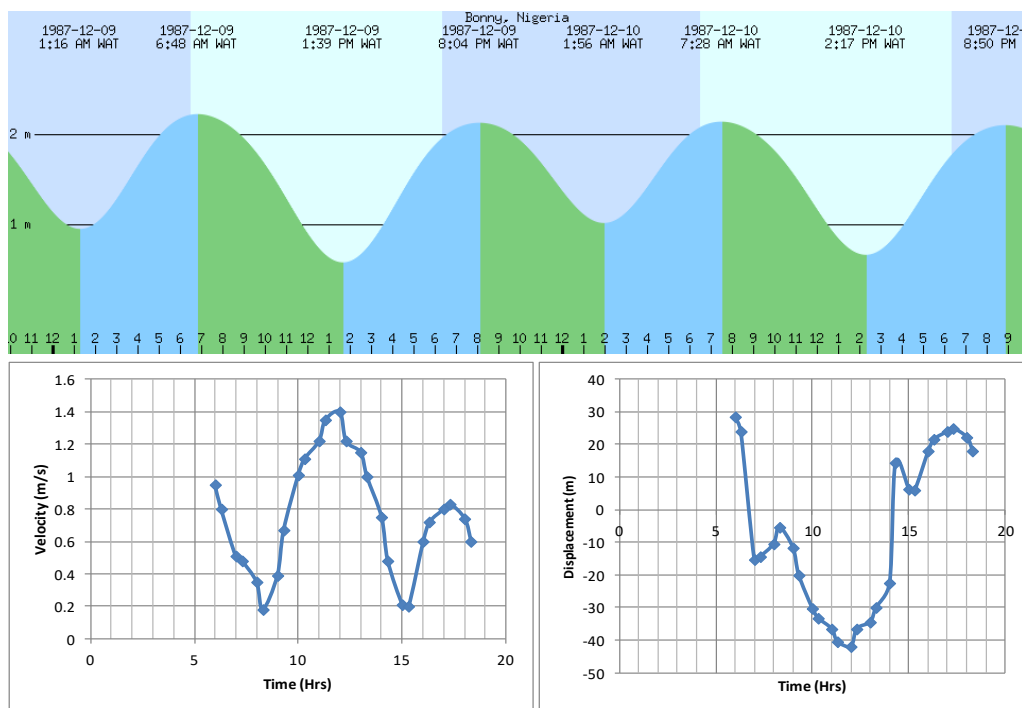
The river system is subject to diurnal tidal inundation with Mean Tidal level averaging 1.52m. Tidal velocities vary across the tidal cycle, with peak velocities up to 1.4m/s occurring at mid ebb tide (Fig.2), with depth averaged velocities that are able to entrain and transport sediments generated as a result of dredging within the river system.

Fig. (2): Tidal regime in study area

The potential for scour for the bridge foundation and abutment was also assessed based on the hydrology of the study area, with tidal velocities peaking at 1.2m/s. The turbidity of the water indicated the movement of substantial suspended load in the flow. Since there is reasonable narrowing of the flow area at bridge crossing location, the river flow velocities are expected to increase significantly. Under these flow conditions, it is highly probable for the development of scour around the bridge piers and abutments. Furthermore, if a bridge pier is within the area of influence of a borrow pit, then it is probable that additional scour arising from bed instability

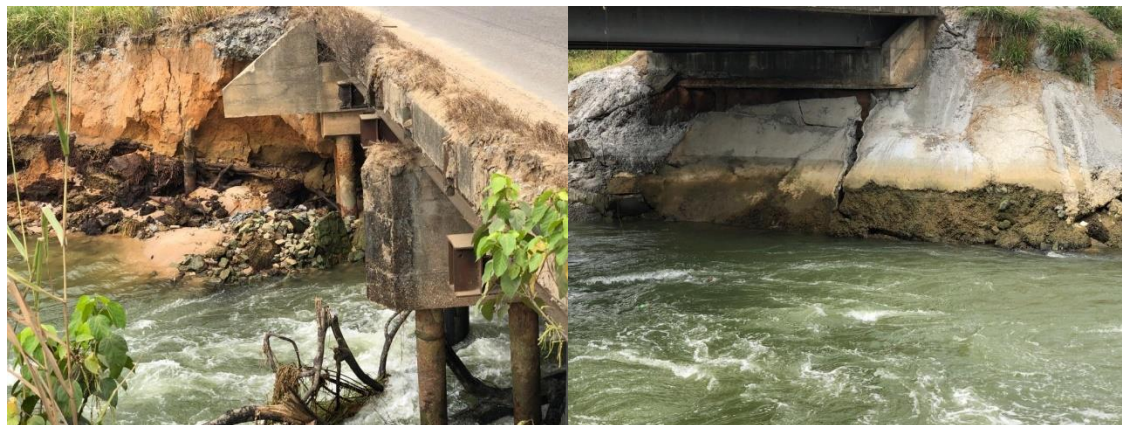
In much the same fashion, the dredging lowered the basal level, triggering sub-aqueous slope and riverbank instabilities. The evacuation of the additional volume of water in the excavated space within the diurnal tidal cycle implies that flow velocities and by extension the discharge would be increased. Measured tidal velocity based on timing of floats indicated an increase of 37% in the peak ebb tide flow velocity. The combined effect of slope instability caused by basal lowering of the riverbed and the increased tidal discharge through the bridged channel section eroded the abutment and is currently threatening the stability of the bridge itself. Fig. (5) shows the current state of the bridge abutment, with eroded banks and scoured piles which effectively reduces pile capacity.

Fig. (5): Akpajo Bridge abutment deterioration Upstream Reach Okpoka River

Repeated attempts to protect the bridge with crushed stones gabion construction have failed, because the protective structure could not withstand the turbulence associated with the increased flow.

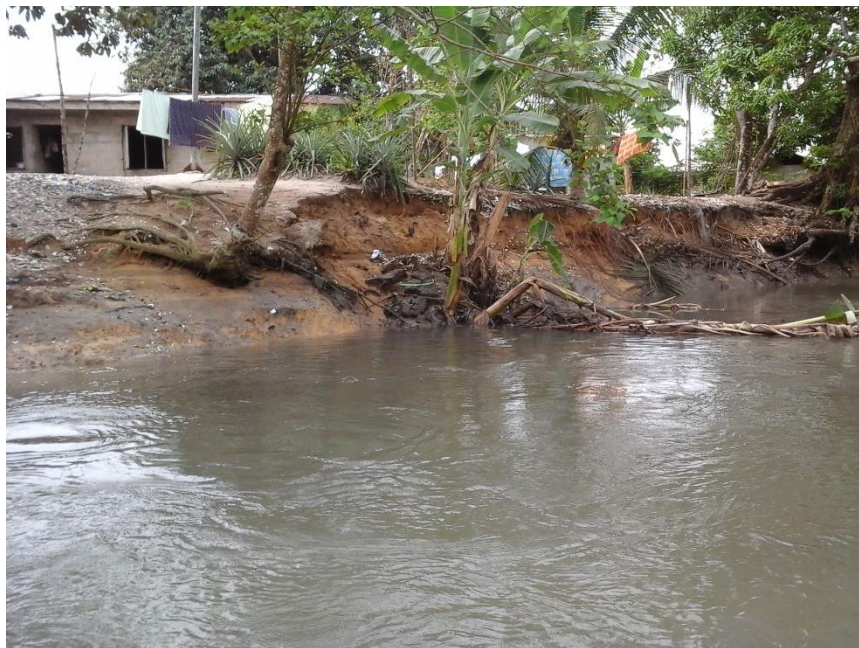
This case study explores the incidence of accelerated erosion triggered by dredging neighbouring sections and deepening of river channel up to 14m (Fig.8). This activity compromised the functioning of a drainage channel, resulting in discharge redistribution and consequently accelerated erosion (Fig.9). By measuring channel dimensions and flow velocity, discharges from the interconnected drainage channels were computed and compared to values prior to dredging. The results indicated 30% increase in discharge through the tertiary channel, suggestive of lateral channel expansion, which is equated to accelerated bank erosion, of approximately 3m.

Fig. (9): Failed sections of River Bank due to accelerated erosion

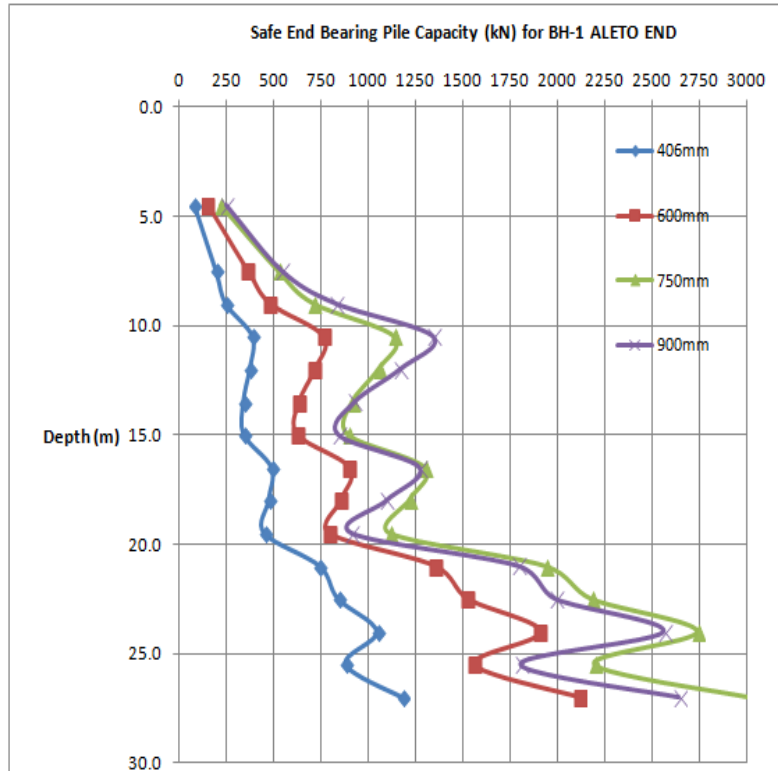
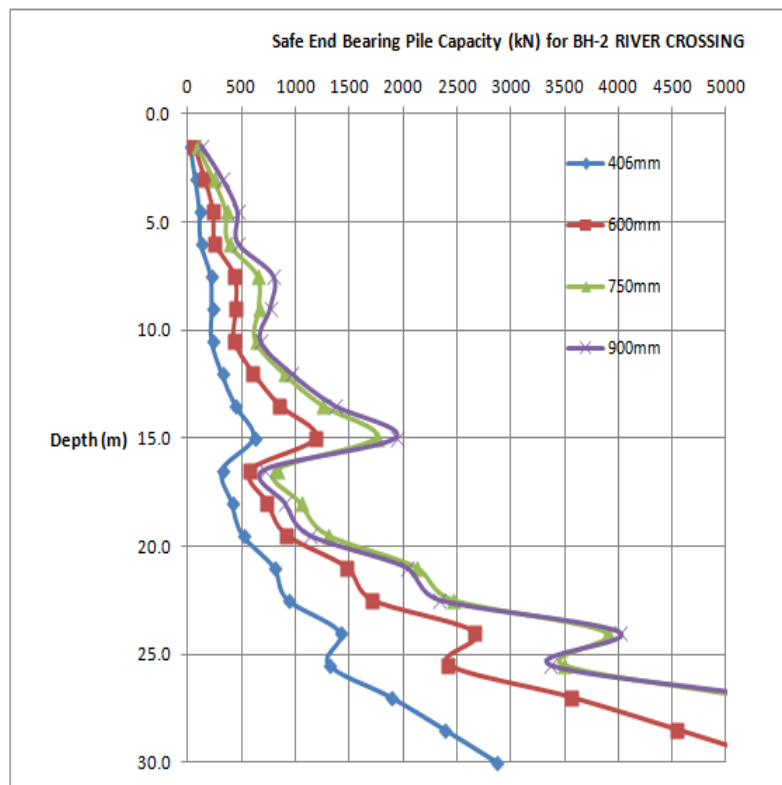
caused by the pit can be introduced. Such scour is to be checked against the depth of pile embedment in order to assess its significance with respect to the continuing stability of the pile or pier as the case may be. Fig. (11) presents the axial pile capacities for various pile diameter on the proposed Worji-Alode crossing. Scour resulting in the removal of 8m of bed material is expected to reduce axial pile capacity by 34% or more.

Fig. (11): Axial pile capacity of driven piles across the Okpoka River.
